Fynspray WS 67 ULTRA GALLEY PUMP

REPAIR INSTRUCTIONS

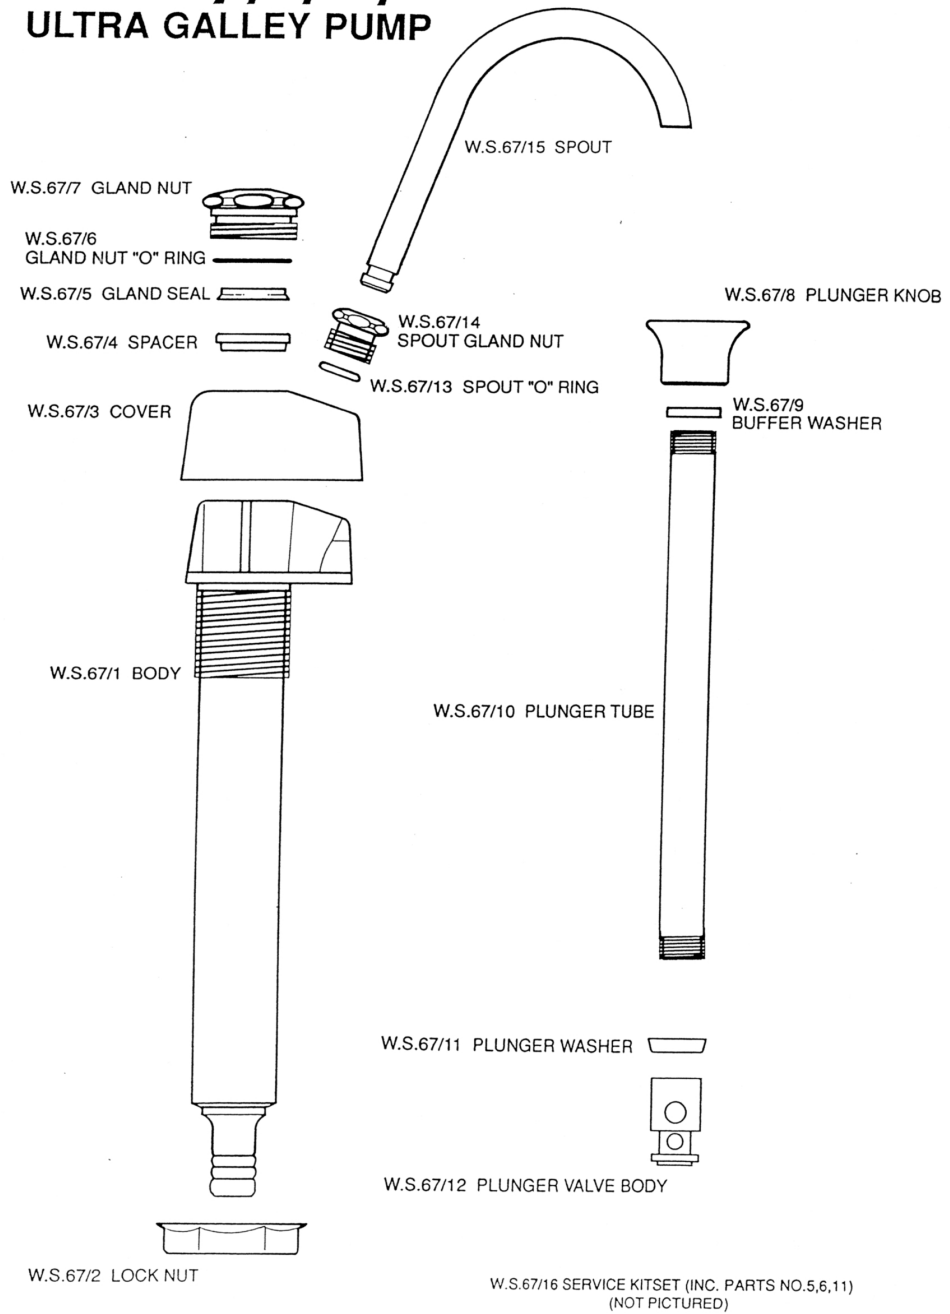
W.S. 67 *Fynspray* ULTRA GALLEY PUMP

To replace the plunger washer (#11) – Loss of suction

Unscrew the gland nut (#7) which enables the complete plunger assembly to be removed. Check that the plunger washer (#11) is soft & pliable and that it is a push fit inside the pump barrel. If it is not a push fit and/or is cracked it must be replaced.

To replace, immerse plunger washer in hot water, when warm slide over the bottom of plunger valve. Ensure the cup is up, as per diagram. Apply a little food oil to assist assembly. The plunger washer should slide freely in the barrel.

To replace the gland seal (#5) – Leaking of the gland

Having removed the complete pump assembly (as above) unscrew the plunger valve body (#12) [earlier models unscrew the plunger knob (#8)]. DO NOT HOLD THE PLUNGER TUBE IN ANY TOOLS AS THEY MAY CAUSE DAMAGE. When replacing or removing the gland seal onto the plunger wind it in the direction of the plunger thread so as not to damage the lip edge.

The gland nut 'o' ring (#6) is also included in the Service Kitset and whether replaced or not should be lubricated with a little Vaseline.

Note that both the gland nut (#7) and the spout gland nut (#14) should not be over-tightened.

Parts #5, 6, & 11 are contained in the service kitset.
